Mr. Jim Wolohan
 Architectural Evaluations of 406 and 408 Great Falls Road
 Page 12

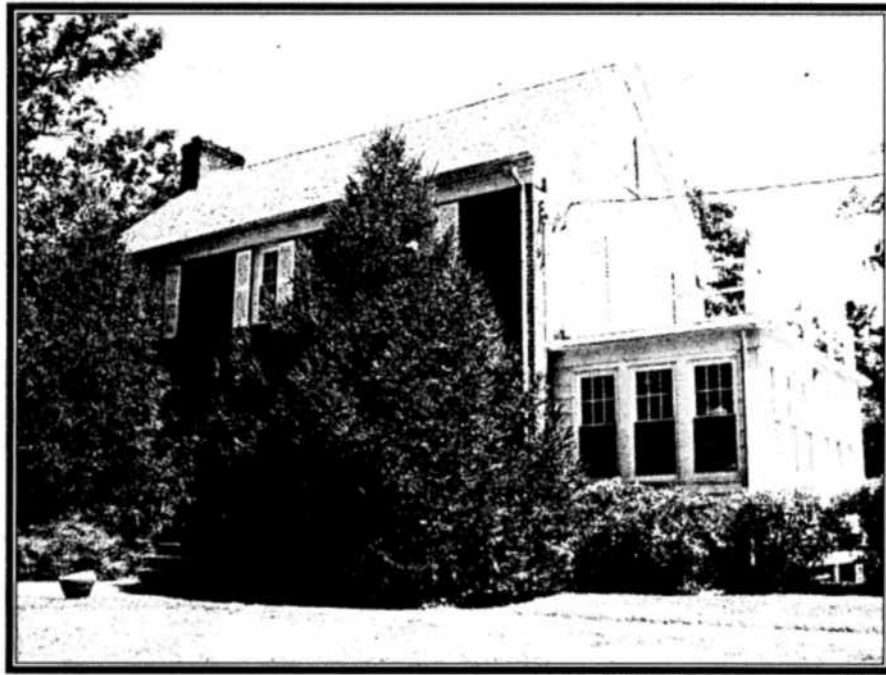
Constructed ca. 1940, the building at 408 Great Falls Road is a two-story, three-bay, masonry-veneer dwelling interpreted in a vernacular Colonial Revival style (Figure 8). The building lies within a landscaped yard and is oriented to the northwest. A brick-veneer foundation supports the building, which terminates in a moderately-pitched, side-gable roof covered in slate. Openings of the façade include a door with detailed architrave and two one-over-one, double-hung, vinyl-sash replacement windows with snap-in, six-light grilles.

The façade is pierced by a centrally located six-panel door with decorative architrave. Details include a reproduction hood and fluted pilasters. Two windows flank the door on the first floor. The windows are one-over-one, double-hung, vinyl-sash replacement windows with six-light, snap-in grilles and permanently mounted synthetic shutters. The shutters are installed in the opposite orientation of historic use. Windows of the second floor include vinyl replacement windows directly above those of the first floor, and a one-over-one, double-hung, vinyl-sash replacement window with four-light, snap-in grilles over the door. The eaves terminate in an aluminum clad cornice and box soffit. Aluminum sheeting covers the historic, molded cornice.

Figure 8. 408 Great Falls Road, west elevation.

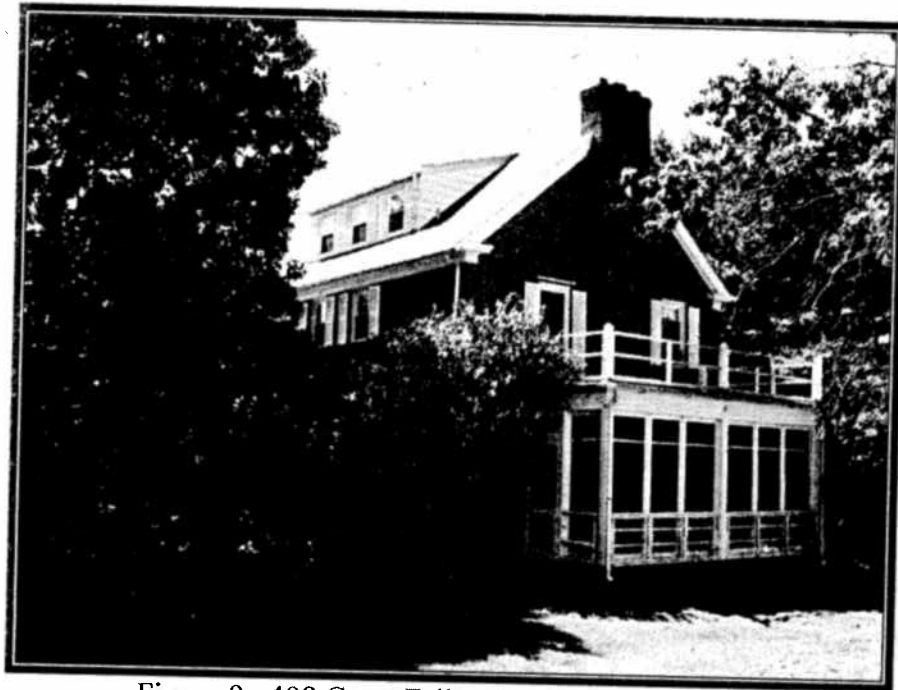
The left elevation is defined by a screen porch and an exterior, end chimney (Figure 9). The porch is accessed by a ten-light door on both the first and second levels. One-over-one, double-hung, vinyl-sash replacement windows with six-light, snap-in grilles fill the other openings of each level of the elevation. Synthetic shutters flank the openings. The porch is covered by a shed roof clad with rolled-asphalt and encircled by a wood balustrade of tapered posts and simple, horizontal rail. The posts and rail are apparent replacements. The end chimney is centrally located and terminates in a corbelled cap. The aluminum-covered cornice exhibits slight returns, and the verge boards are also covered with metal sheathing.

Figure 9. 408 Great Falls Road, north elevation.

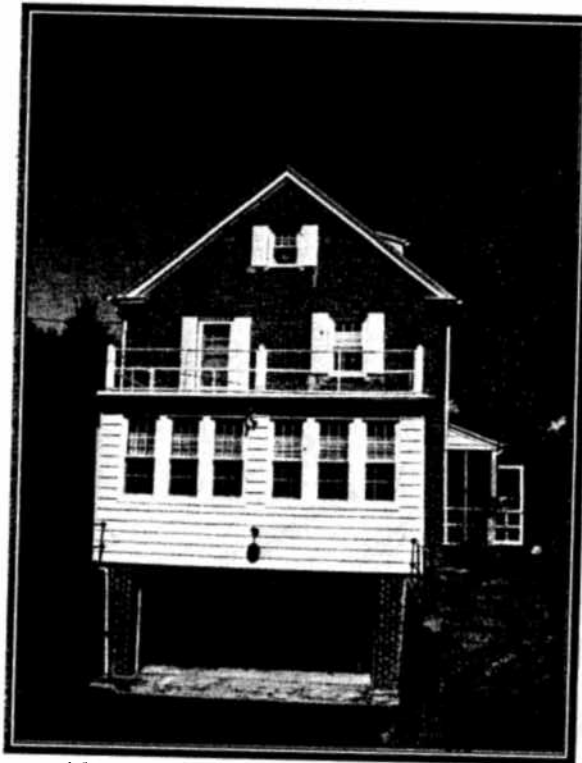
The right side elevation contains an enclosed porch located above a two-car garage located on the basement level (Figure 10). Porch fenestration is composed of triple, one-over-one, double-hung, vinyl-sash replacement windows with six-light, snap-in grilles. The front and rear walls contain a single, three-sash unit; two units are located on the side walls. The frame walls of the porch are clad with aluminum siding. A multi-light wooden door accesses the porch from the dwelling. The second floor contains two openings; a twelve-light door and a one-over-one, double-hung, vinyl-sash replacement window with six-light, snap-in grilles. A similar window fills the apex of the gable wall. All openings are framed by permanently-mounted synthetic shutters. The garage is accessed through a full-width, sectional overhead door. The cornice returns and verge board are clad in aluminum sheathing.

Figure 10. 408 Great Falls Road, south elevation.

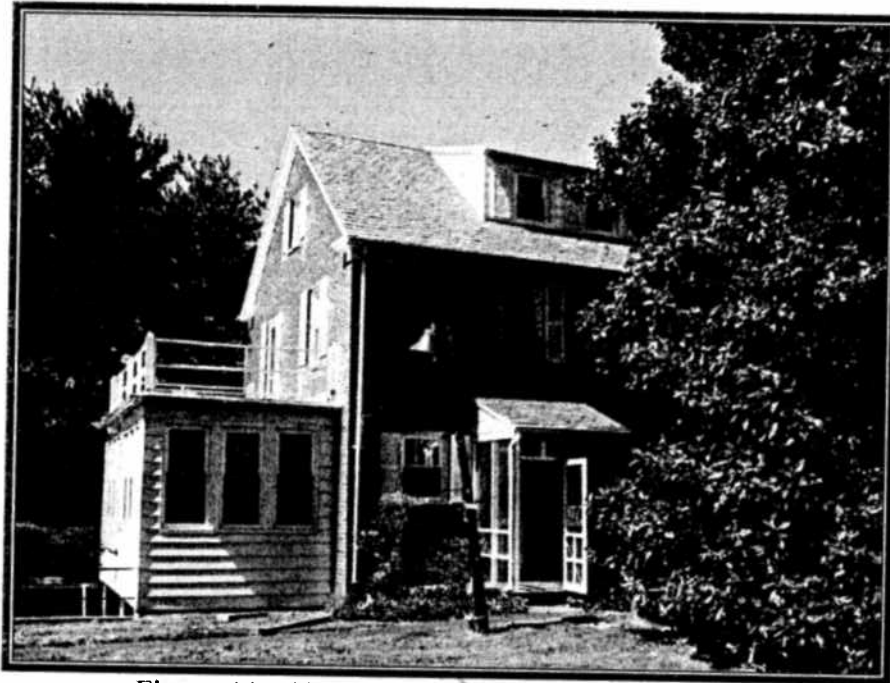
The rear elevation is pierced by a nine-light door and one-over-one, double-hung, vinyl-sash replacement windows with six-light, snap-in grilles (Figure 11). The door is sheltered by a shed-roofed, screened porch. A shed dormer breaks the rear slope of the roof. The dormer walls are clad in aluminum siding. The dormer contains three, one-over-one, double-hung, vinyl-sash replacement windows with six-light, snap-in grilles. The dormer roof is clad in standing-seam metal.

Figure 11. 408 Great Falls Road, east elevation.

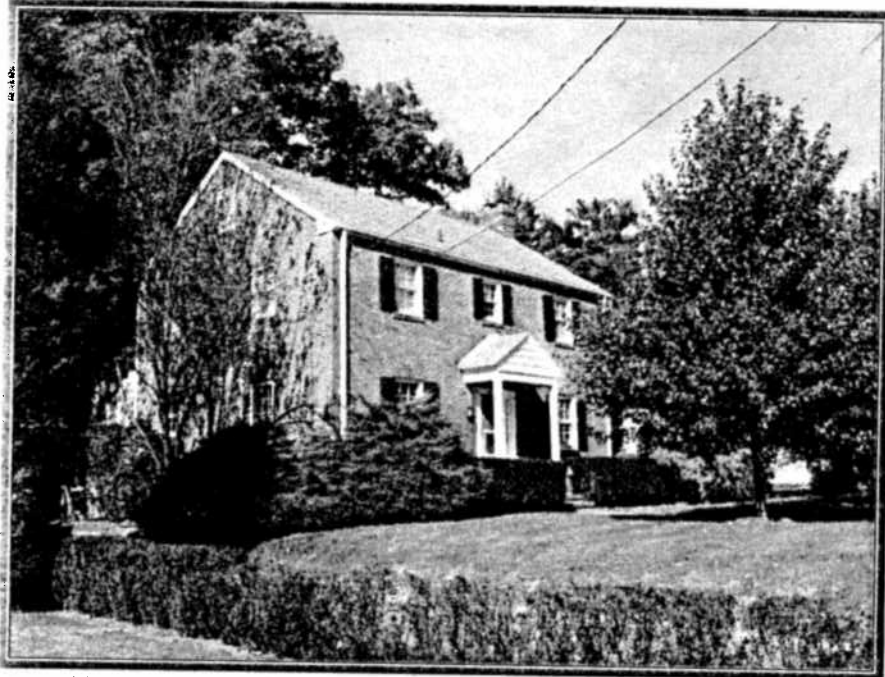
There are numerous examples of Colonial Revival in the vicinity of 408 Great Falls Road. An informal windshield survey conducted the week of September 12th identified over 15 buildings in the immediate vicinity that exhibit similar stylistic attributes (Figures 12-14). Many of these

Figure 12. Colonial Revival residence with high integrity, Adams Street.

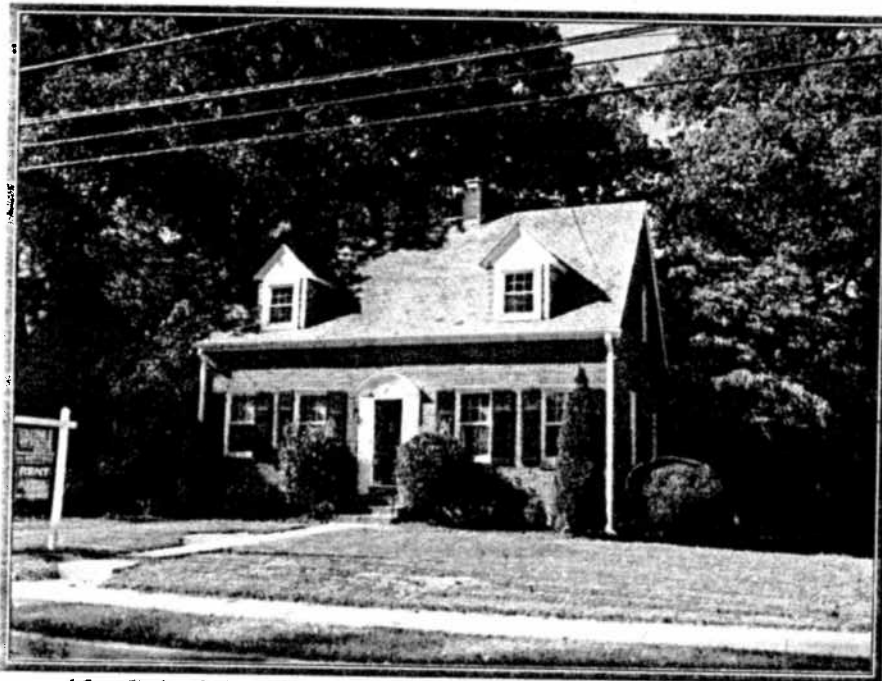
Figure 13. Colonial Revival residence with high integrity, Adams Street.
